DEPARTMENT OF TRANSPORTATION

Quality Assurance and Source Inspection

Contract #: 04-0120F4Cty: SF/ALA Rte: 80 PM: 13.2/13.9File #: 1x.28**WELDING INSPECTION REPORT****Resident Engineer:** Pursell, Gary**Address:** 333 Burma Road**City:** Oakland, CA 94607**Report No:** WIR-015564**Date Inspected:** 12-Jul-2010**Project Name:** SAS Superstructure**OSM Arrival Time:** 700**Prime Contractor:** American Bridge/Fluor Enterprises, a JV**OSM Departure Time:** 1100**Contractor:** American Bridge/Fluor Enterprises, a JV**Location:** Job Site**CWI Name:** Bernard Docena**CWI Present:** Yes No**Inspected CWI report:** Yes No N/A**Rod Oven in Use:** Yes No N/A**Electrode to specification:** Yes No N/A**Weld Procedures Followed:** Yes No N/A**Qualified Welders:** Yes No N/A**Verified Joint Fit-up:** Yes No N/A**Approved Drawings:** Yes No N/A**Approved WPS:** Yes No N/A**Delayed / Cancelled:** Yes No N/A**Bridge No:** 34-0006**Component:** OBG Section**Summary of Items Observed:**

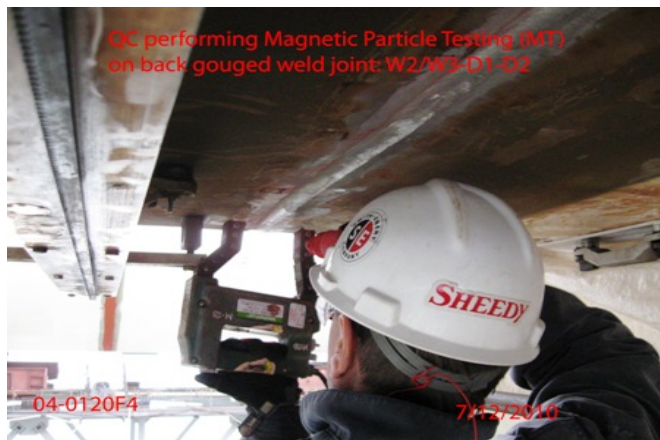
At weld joint W2/W3- D1 and D2, outside the OBG section this QA Inspector randomly observed QC Inspector Tony Sherwood perform the visual and MT inspection on the back gouged weld joint. The technique used by QC to perform the MT inspection appeared to comply with the contract requirements. See photo below. Upon completion of the visual and MT inspection QC Inspector Tony Sherwood informed this QA Inspector he had accepted both inspections. This QA Inspector performed a random visual verification and observed the back gouge appeared to have a “U” shape approximately 35 mm side and 14 mm deep. The work observed appeared to comply with the contract requirements.
